Contract #: 04-0120F4Cty: SF/ALA Rte: 80 PM: 13.2/13.9File #: 69.28**WELDING INSPECTION REPORT****Resident Engineer:**Pursell, Gary**Address:** 333 Burma Road**City:** Oakland, CA 94607**Report No:** WIR-004052**Date Inspected:** 05-Sep-2008**Project Name:** SAS Superstructure**OSM Arrival Time:** 1330**Prime Contractor:** American Bridge/Fluor Enterprises, a JV**OSM Departure Time:** 2230**Contractor:** Zhenhua Port Machinery Company, Ltd (ZPMC), Changxing Island **Location:** Shanghai, China

Bridge No: 34-0006**Component:** OBG Fabrication**Summary of Items Observed:**

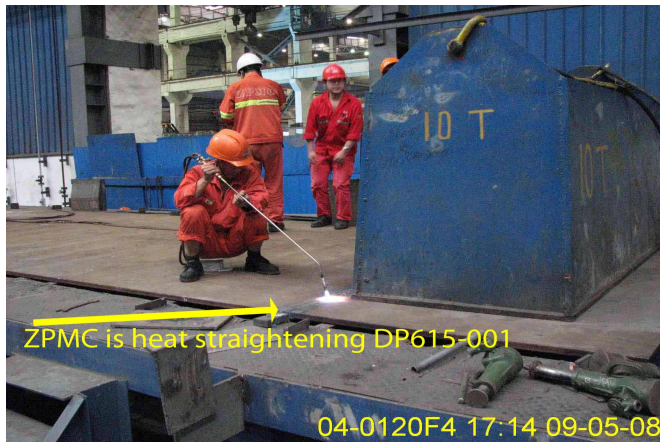
The QA Inspector observed ZPMC personnel are performing heat straightening of deck plate DP615-001 as directed by HSR1(B)2235 in the area where two base plates have been welded together. ZPMC has a 10 ton weight adjacent to the weld that is being heated and one QC Inspector is measuring and recording the base material temperatures at regular intervals. Items observed appear to comply with project specifications. See the photograph below for additional information.
